**CASE STUDY: STEERING INCIDENT**

**LOCATION:** Western Australia  
**YEAR:** 2022  
**APPLIC.:** Critical safety incident  
**SOLUTION:** MaxMine Safety

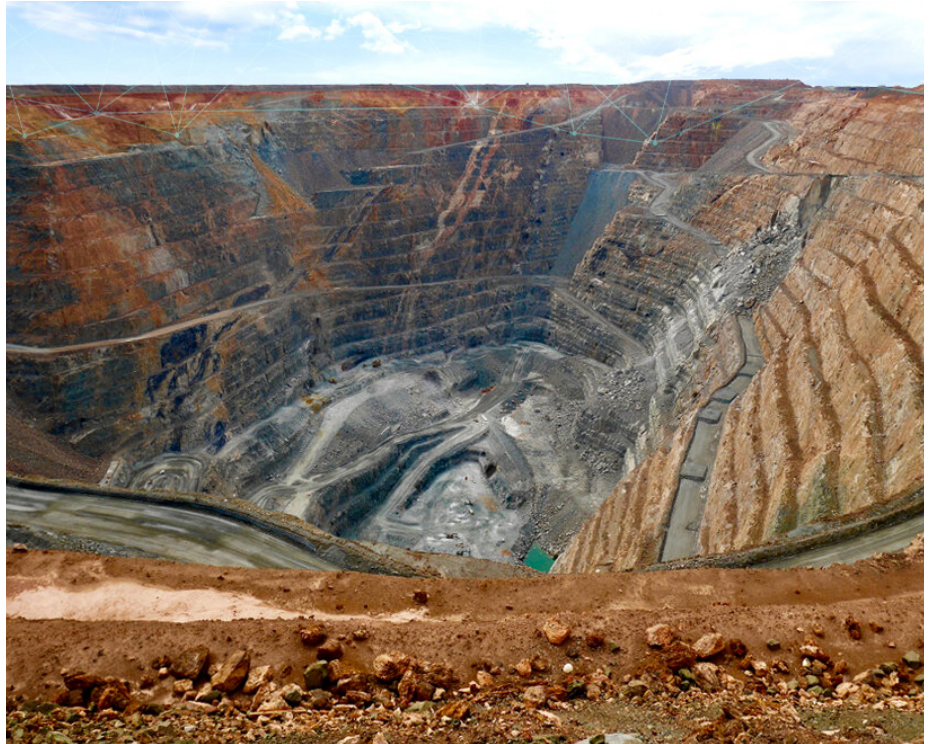
- On the corner, before the loss of steering, the operator was travelling at 23km/h - the fastest speed recorded for the shift and 8km/h faster than average;
- The operator was consistently faster than other operators on that corner throughout the shift;
- No relevant OEM alerts were raised prior to the incident, however steering oil temperature and low steering oil pressure alerts were broadcast by the truck 17 mins after it came to a stop;
- Steering oil pressure and temperature parameters were not broadcast by this truck and therefore MaxMine was not able to record and plot their values for this incident.

Based on the data analysis, MaxMine recommended the following actions:

- Investigate and discuss the possible impact of high corner speed on steering oil pressure or temperature with an OEM specialist;
- If required, investigate which corners may increase the probability of steering oil pressure or temperature abnormalities and defining appropriate corner speeds; and
- If required, leverage MaxMine to help drive safe corner speed conformance.
